**ETHICON, INC.**

SEVEN YEAR DATA FOR TEN YEAR PROLENE™ STUDY: ERF 85-219

This report contains a summary of IR, IV, GPC, OM and SEM data supporting this study.

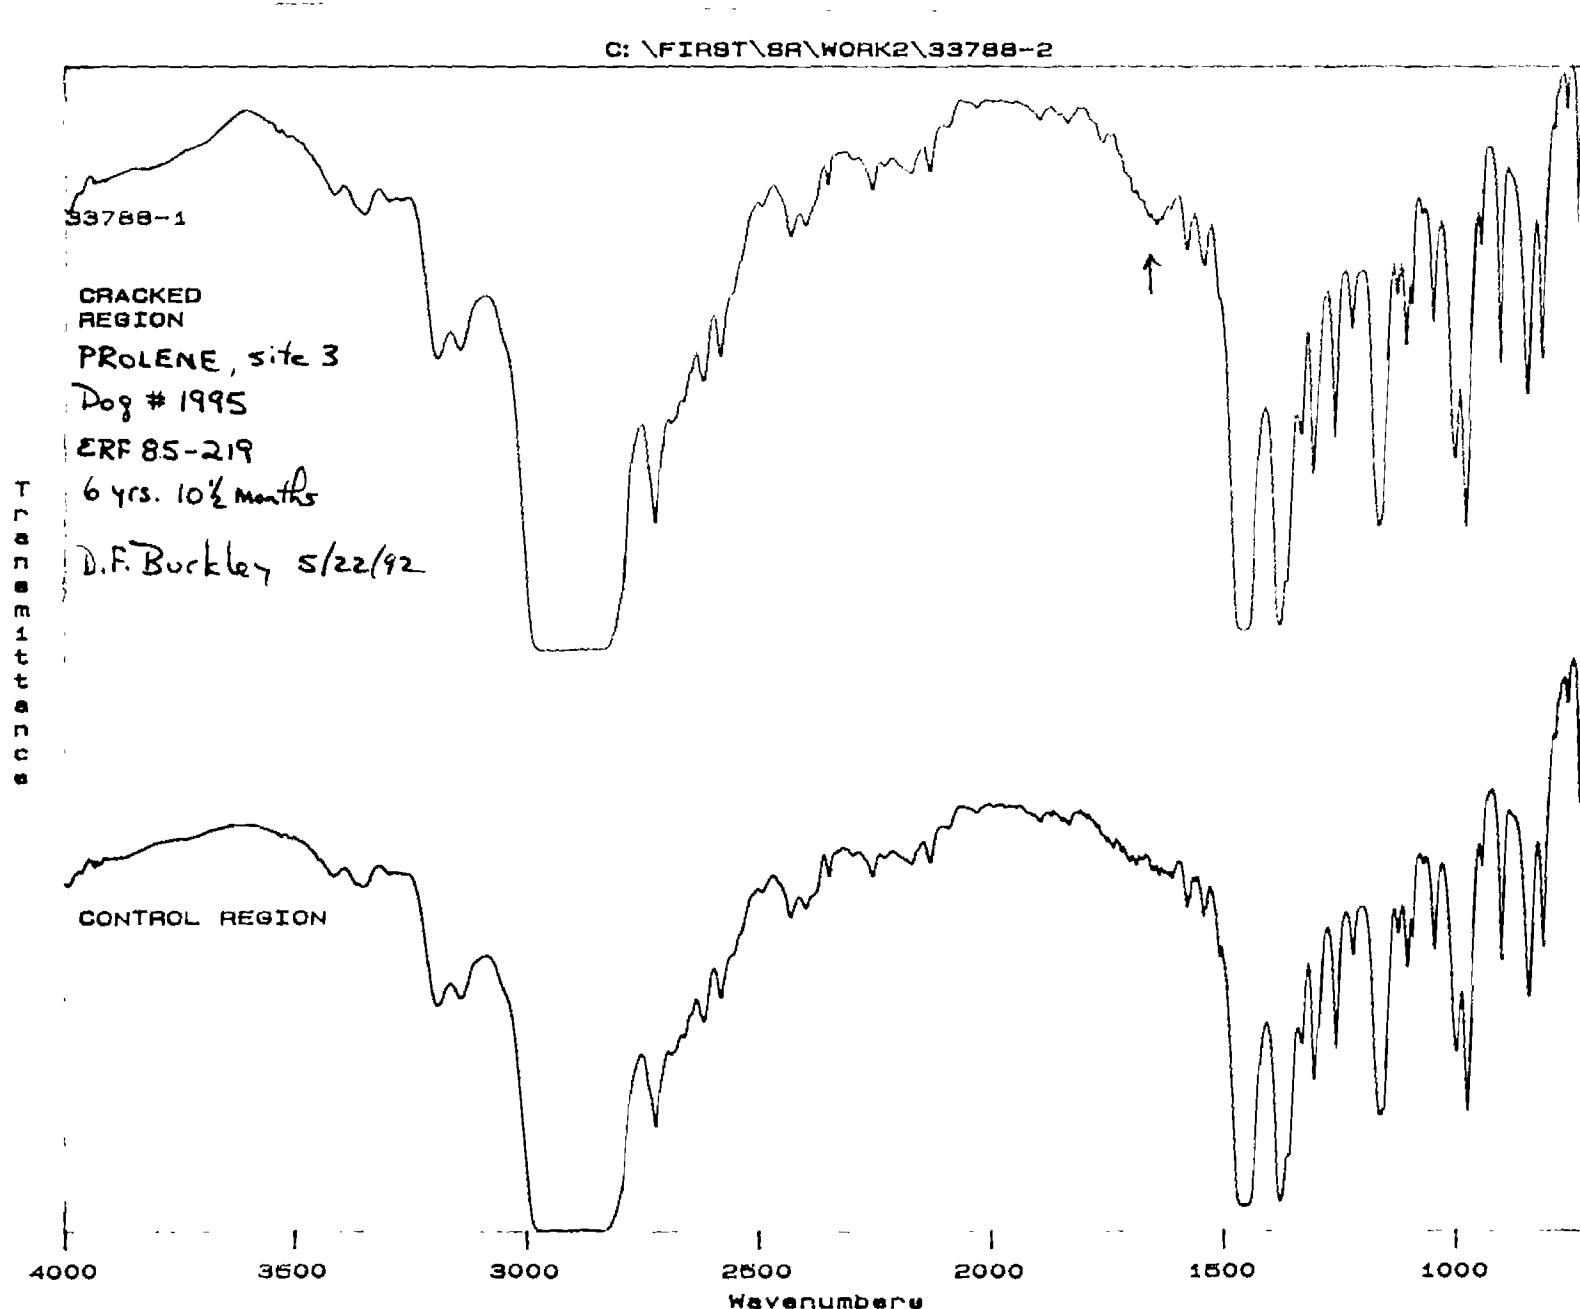
Figure A - Comparison IR Spectra of Cracked and Non-cracked Regions of PROLENE (SR33788)

IR microspectroscopy was used to examine cracked areas in ETHILON, Novafil and PROLENE™ explants. IR spectra obtained for cracked PROLENE specimens (Figure A) showed possible evidence of slight oxidation (a broadened weak absorbance at about 1650 cm<sup>-1</sup>). IR spectra obtained for cracked areas of ETHILON and Novafil did not differ from uncracked areas (Figures B and C), but expected IR absorbances for oxidation would be masked by the strong carbonyl absorbances normally observed for these sutures. Figures D and E show pictures of the areas examined by IR microspectroscopy for ETHILON and Novafil.

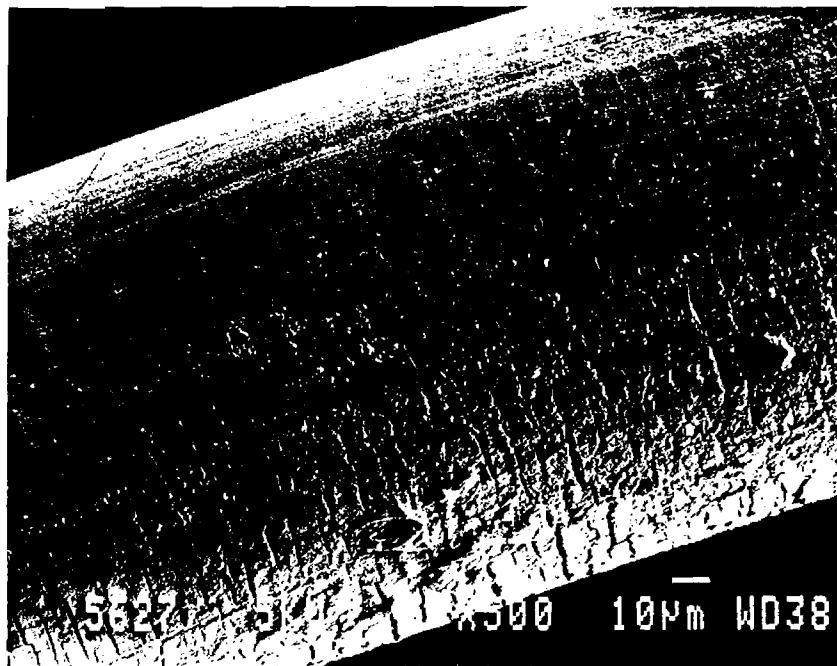
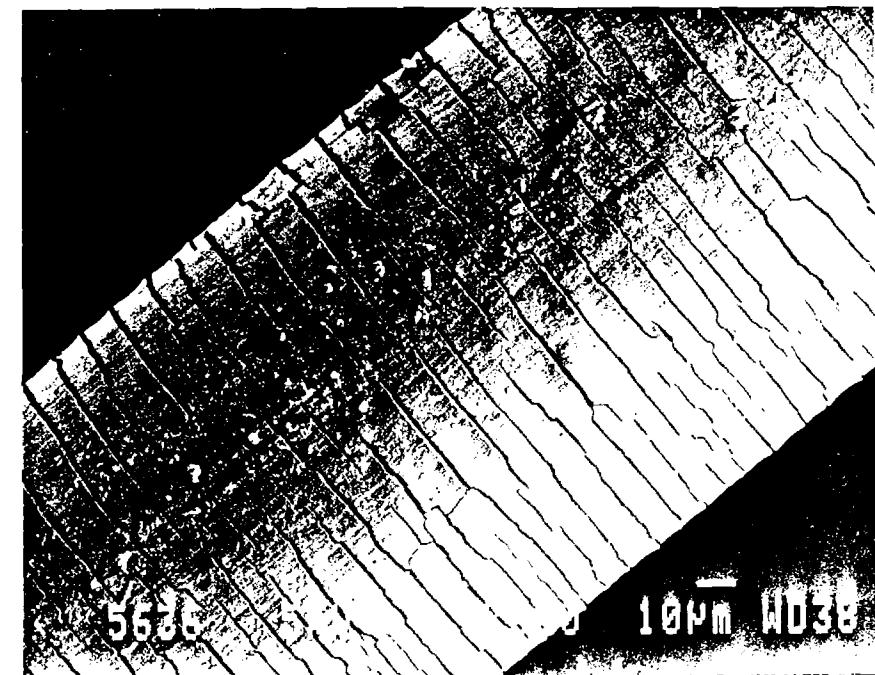
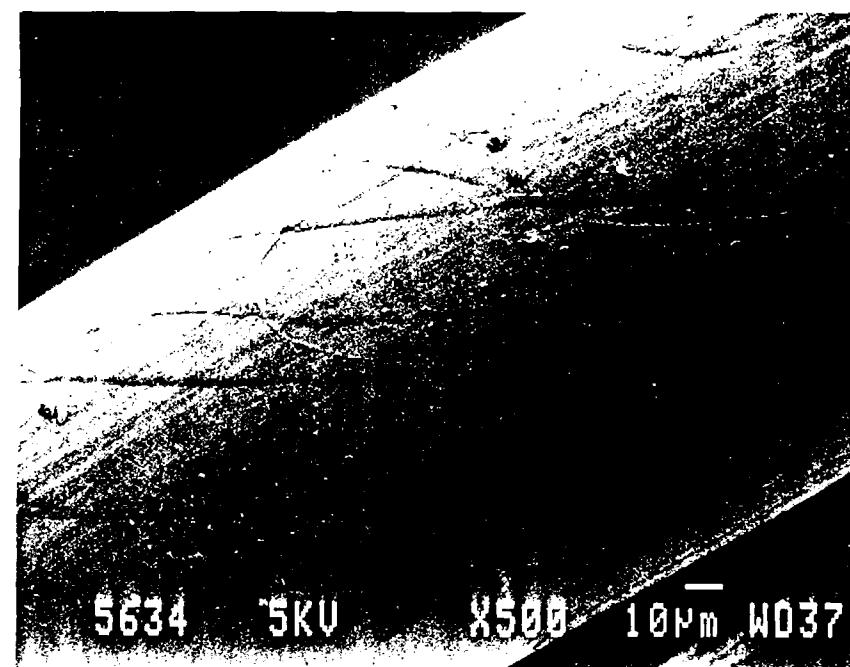
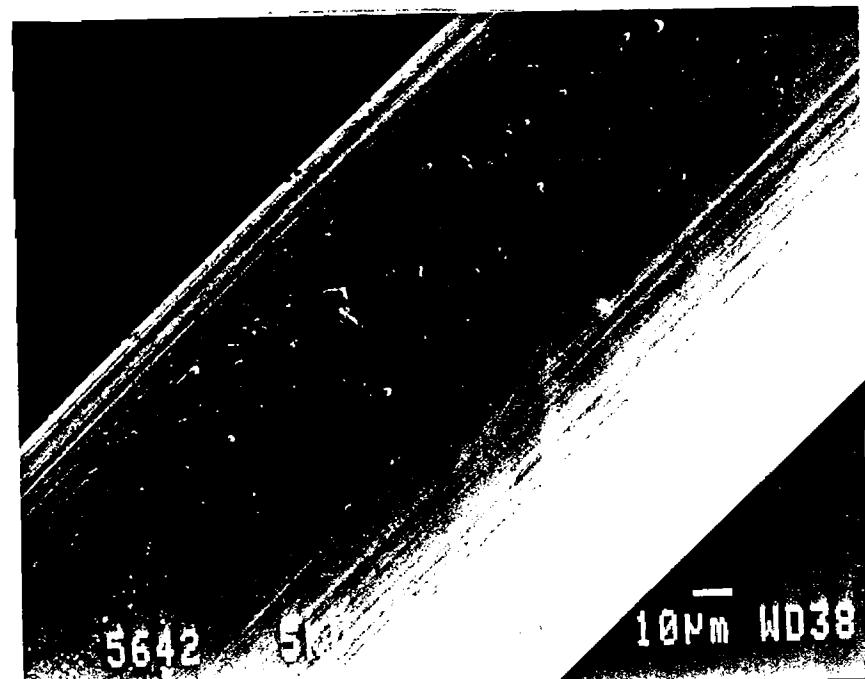
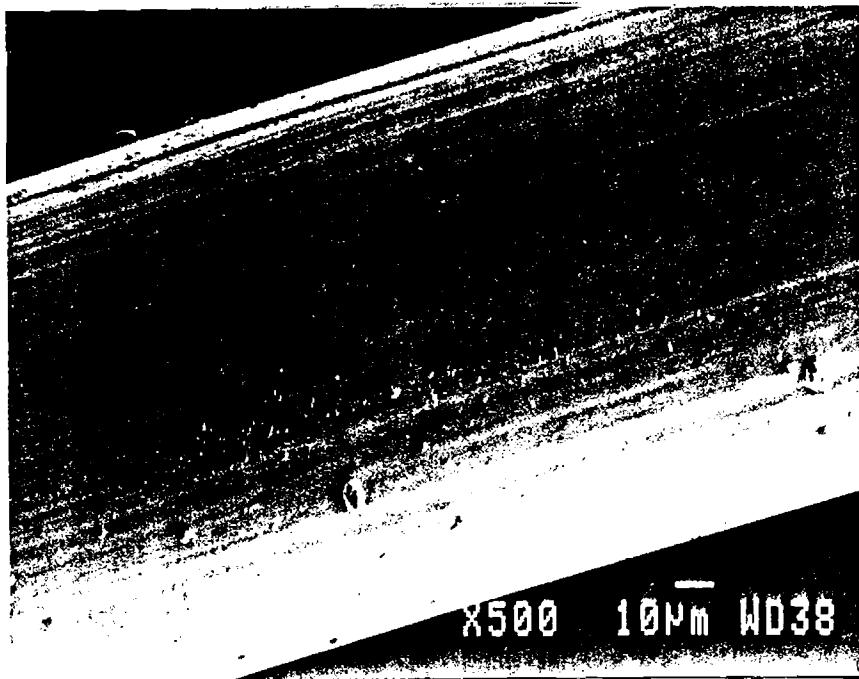
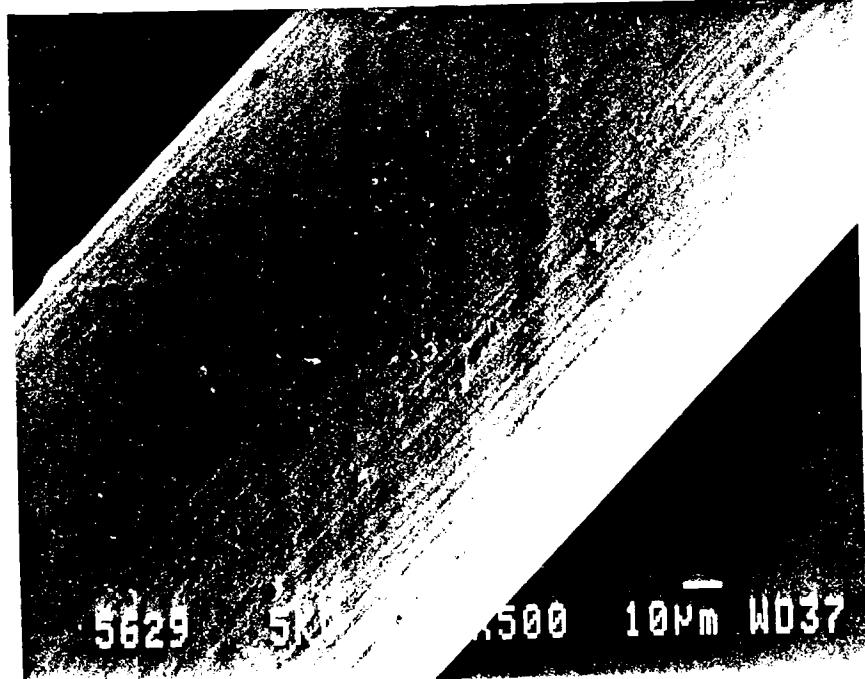
Figure 2 7 Year Prolene Explants

In Figure 1 and 2 SEM views of areas are shown after most of the tissue had been carefully removed. Again out of seven sites sutures from three sites had areas which showed cracking.

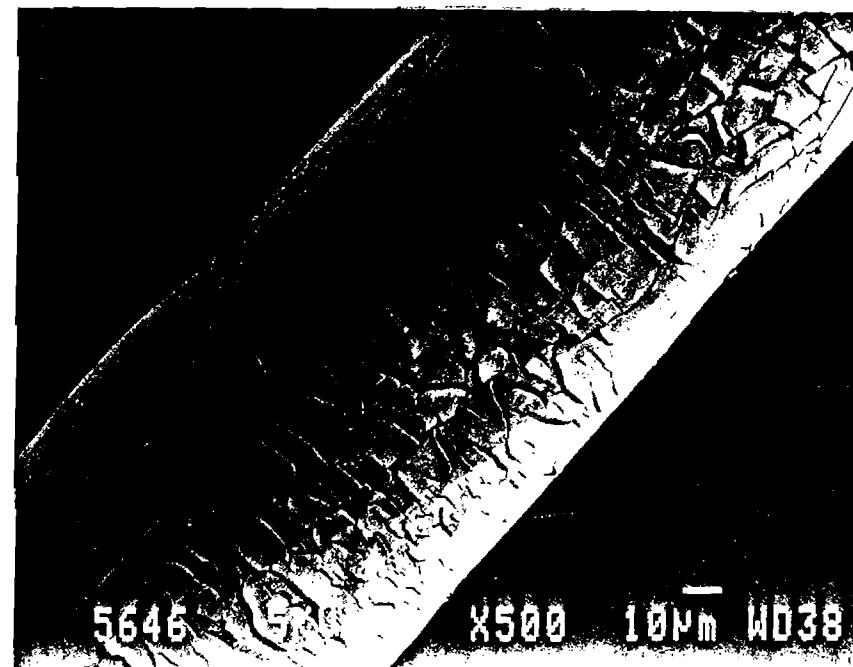
Figure 5A 7 Year PVDF Explants

Figure 5A through 5C show six sites of PVDF explants as seen with the light microscope. Notice the intact surface on all the sutures.

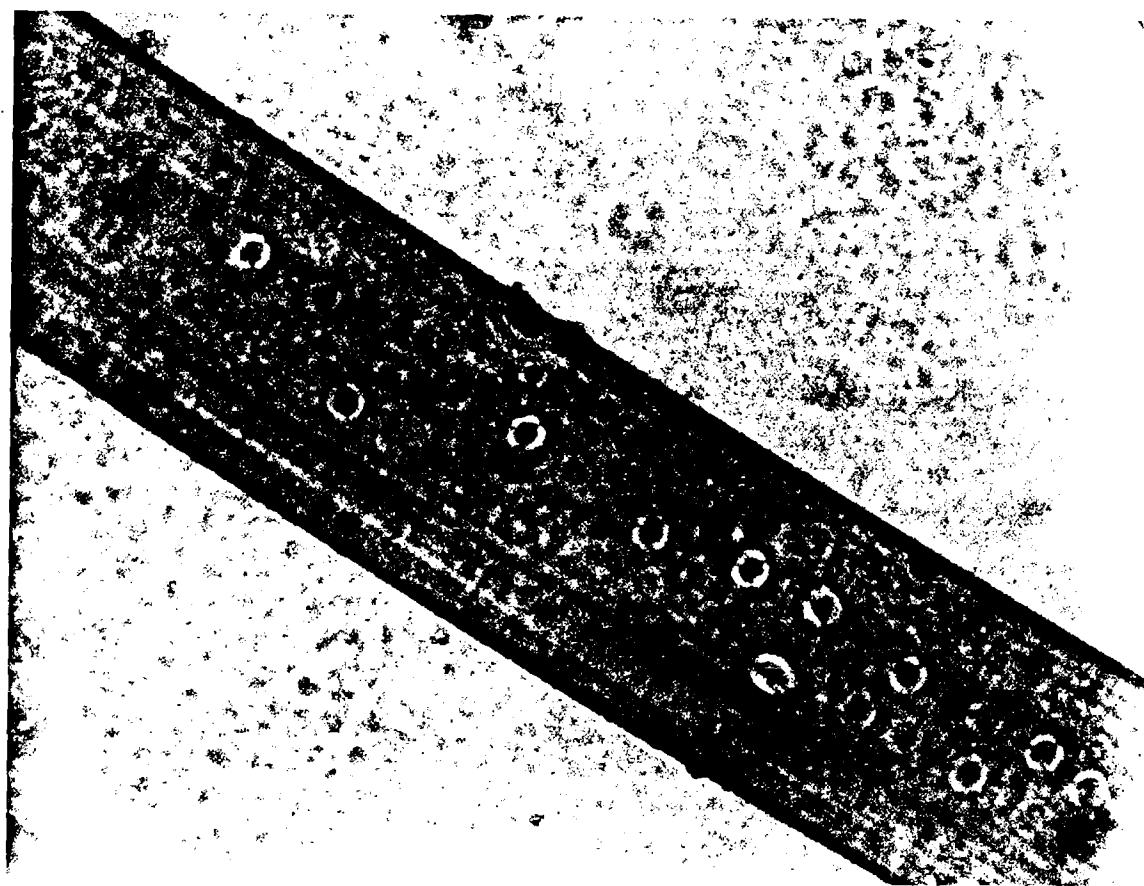
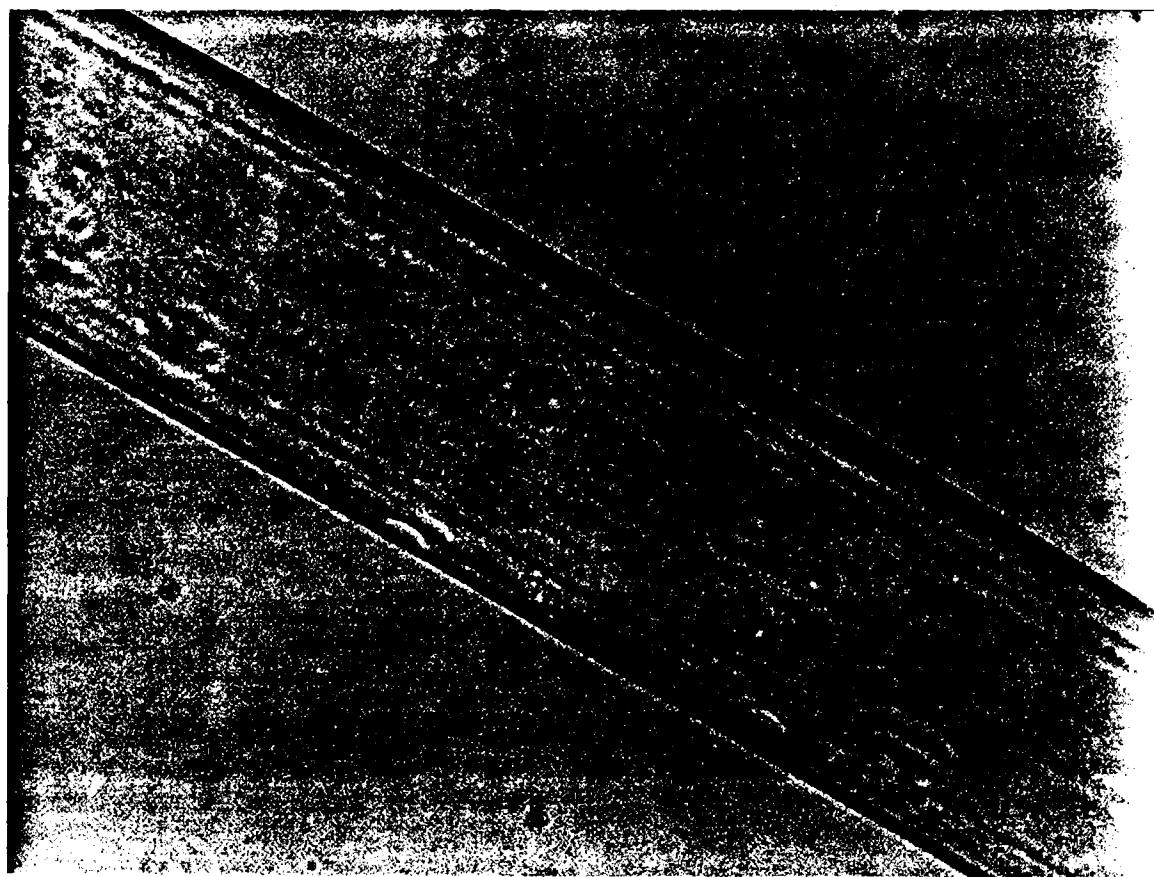
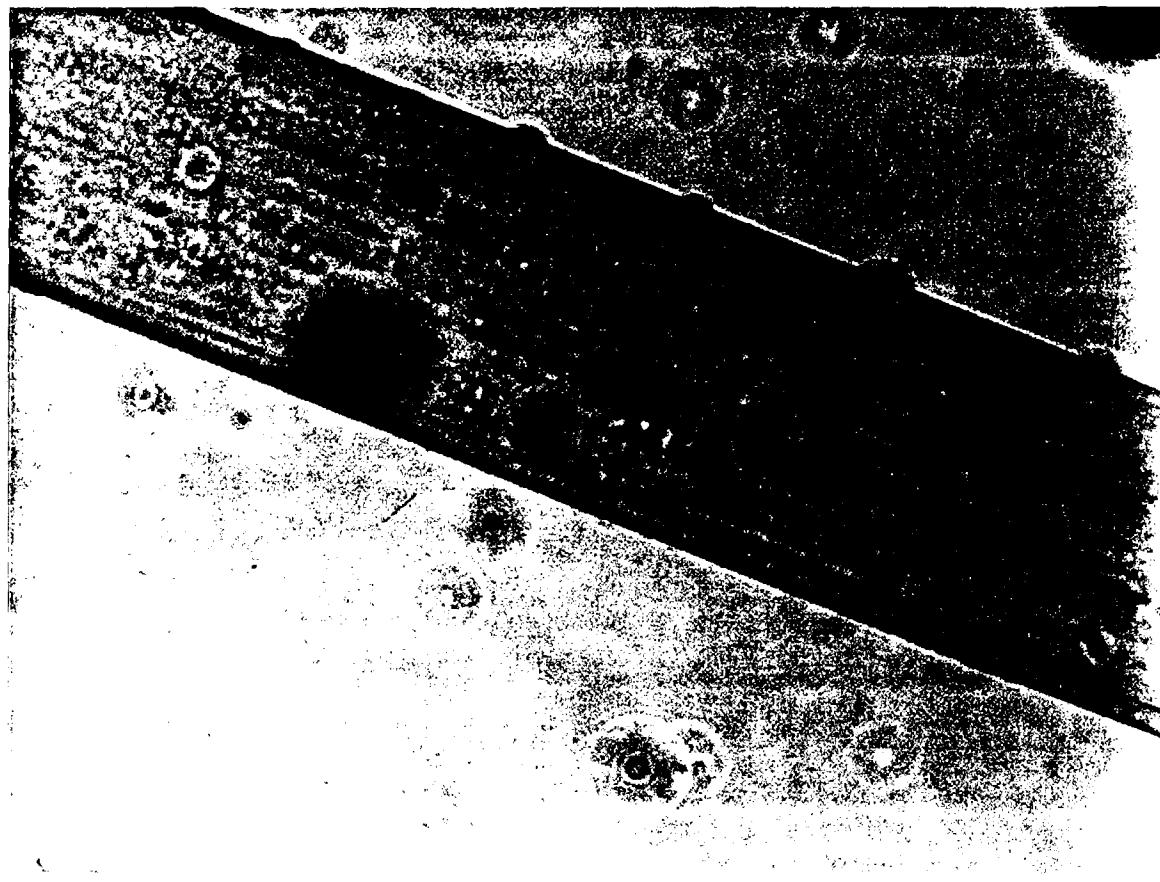
Figure 5 7 Year PVDF Explants

In Figures 5 and 6 the SEM examination of the PVDF sutures is shown. Only on the suture from one site (Figure 6 site 6) some cracks are found. The surfaces of the sutures from the other five sites show some striations which could be mechanical damage, otherwise the surfaces look intact. The contaminant on the site 4 (Figure 5) suture is tissue which had not been removed completely.

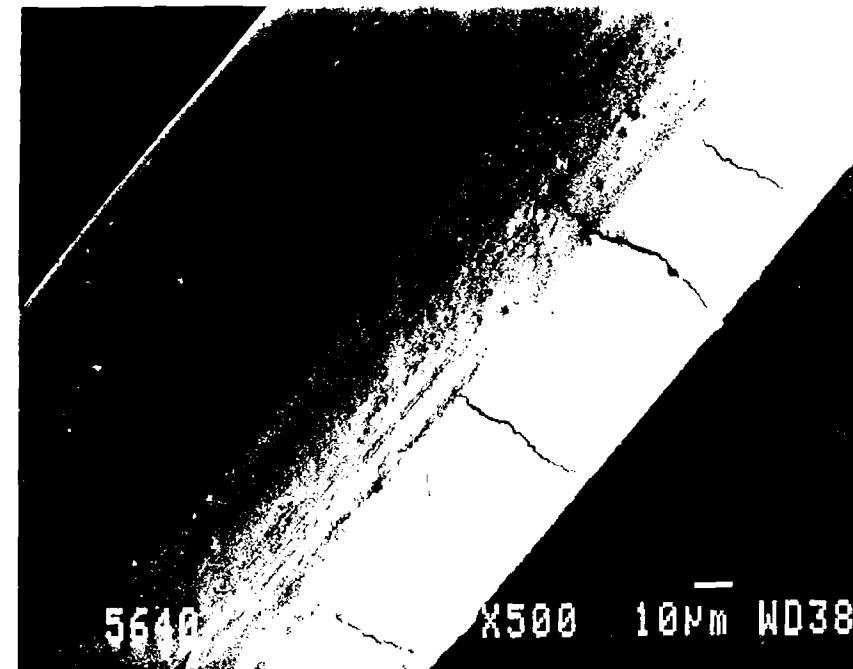
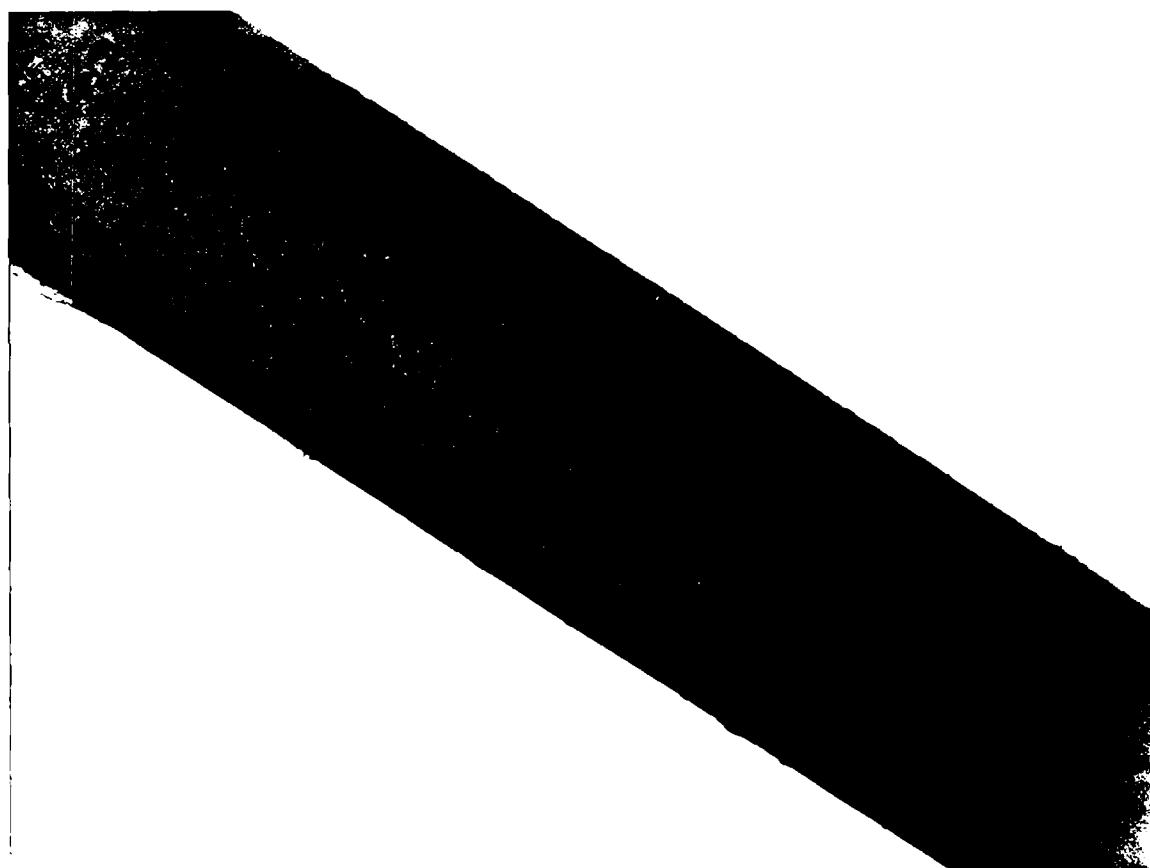
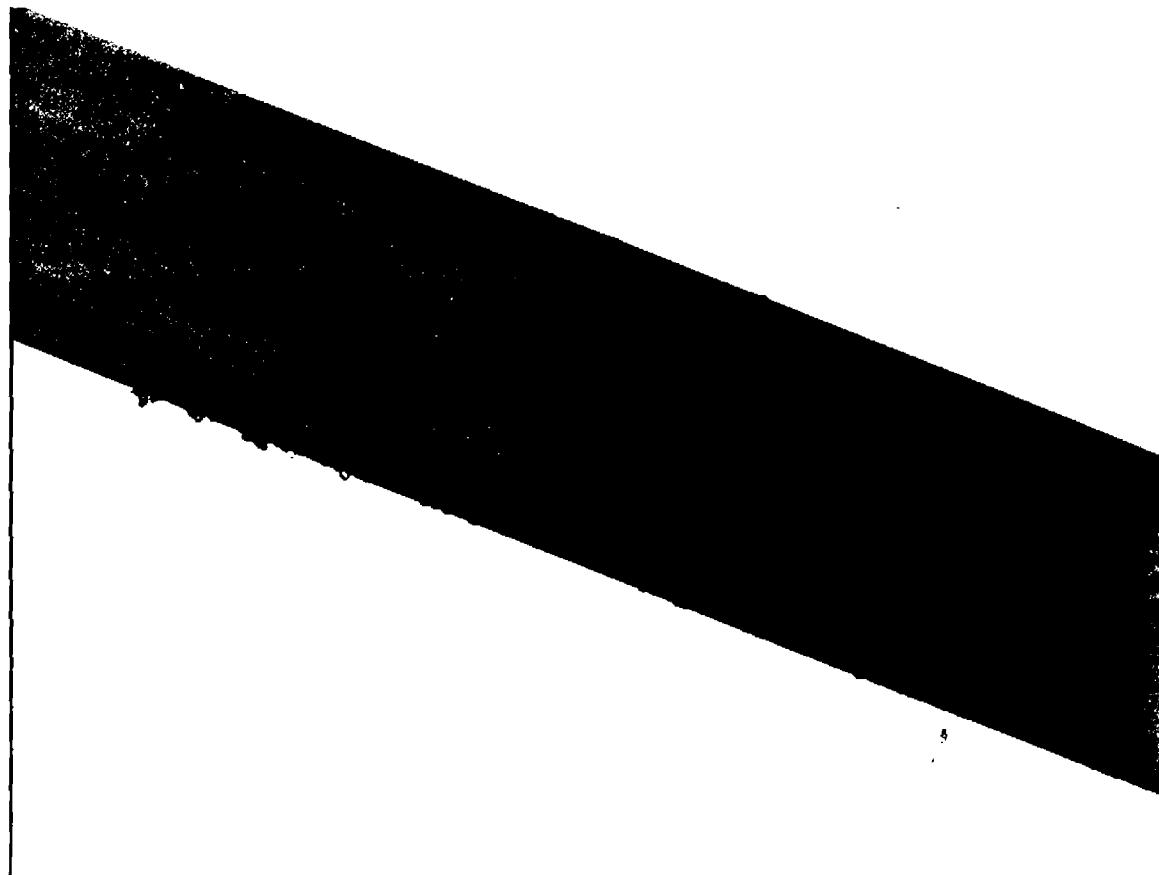
Figure 7 7 Year Novafil Explants

Figure 7A through 7C show the Novafil sutures as observed with the light microscope. All surfaces from all sites look undamaged. Figure 7 and 8 show the SEM examination of these sutures. A few longitudinal scratches and cracks were found, see sites 1,2,3 (Figure 7,8). Also on the site 2 suture (Figure 8) still adhering tissue is found.
